# **Swift House**

## **HISTORIC RESOURCE NEEDS ASSESSMENT REPORT**

Prepared for:  
**Town of Kent Board of Selectmen**  
41 Kent Green Boulevard  
Kent, CT 06757

Silver Petrucelli + Associates  
3190 Whitney Avenue | Hamden CT 06518  
311 State Street | New London CT 06320  
203 230 9007 [silverpetrucelli.com](http://silverpetrucelli.com)

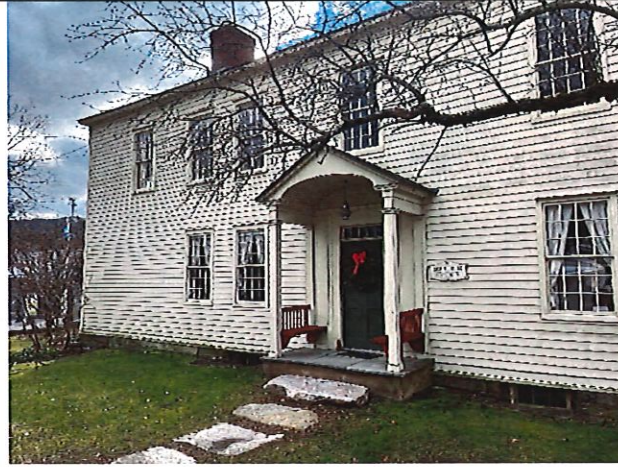
Front entrance on Maple Street

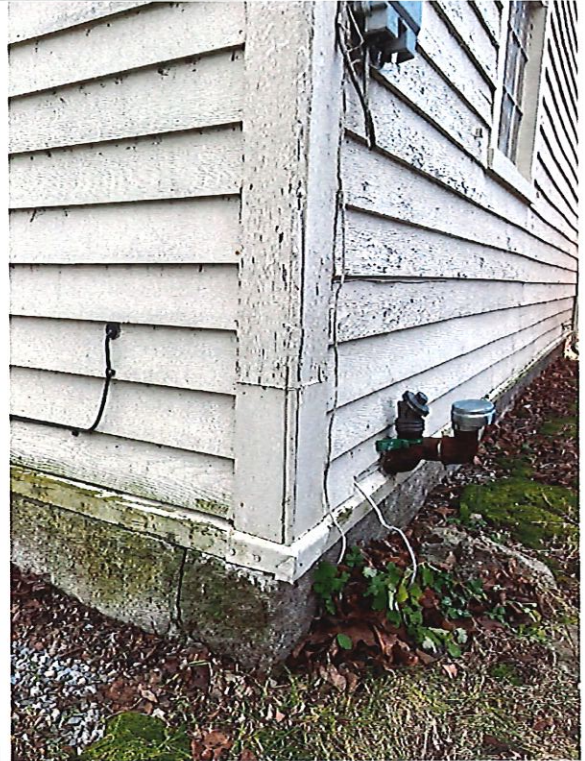
Façade damage

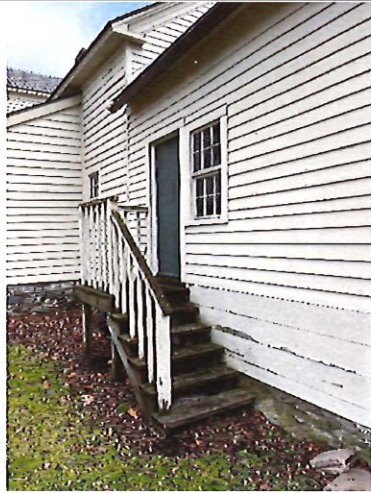
Back steps

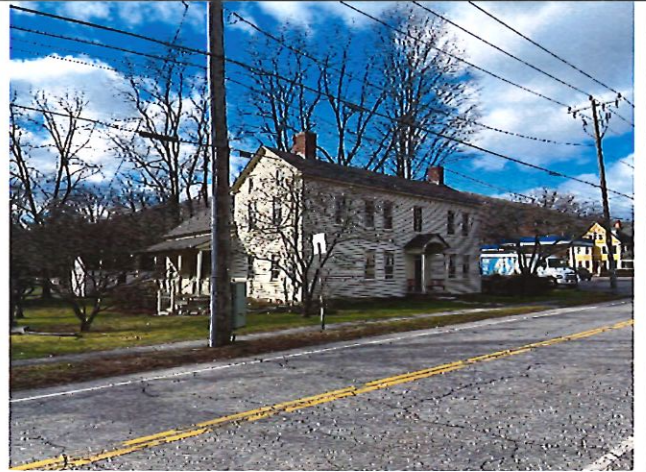
View from Maple Street sidewalk

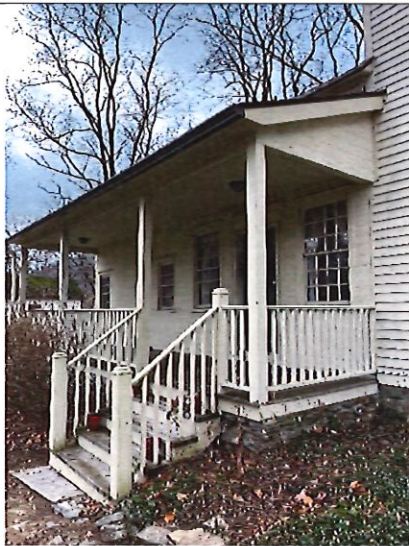
Southeast addition entrance

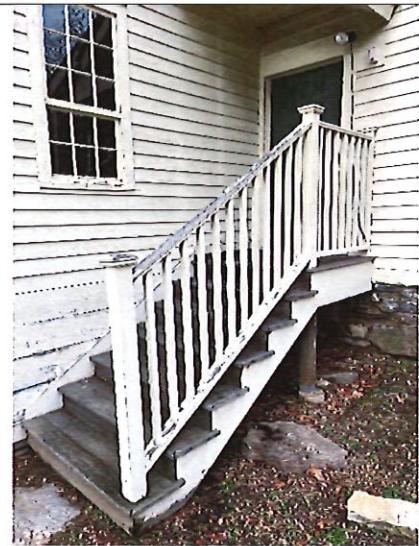
South Entrance

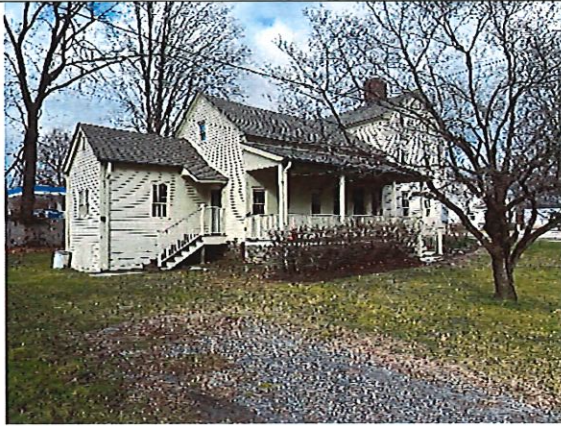
South addition from rear

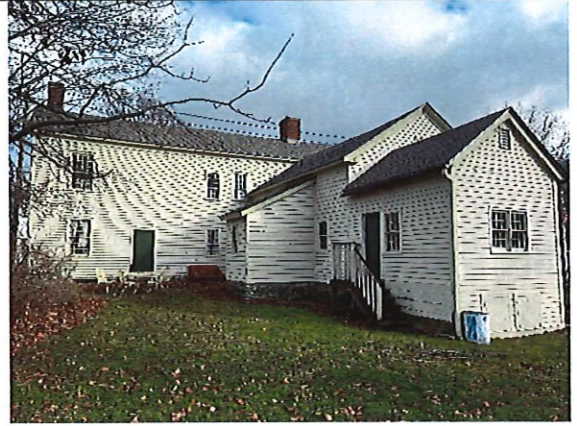
View from southwest

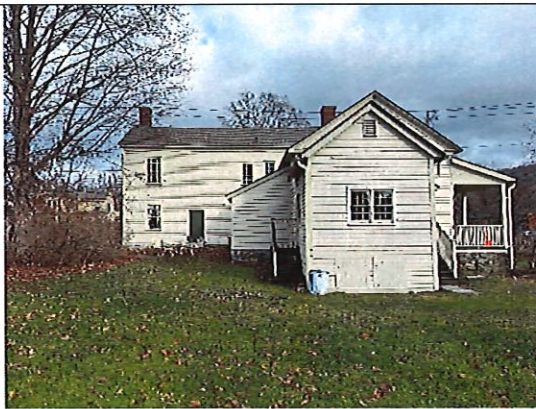
South elevation

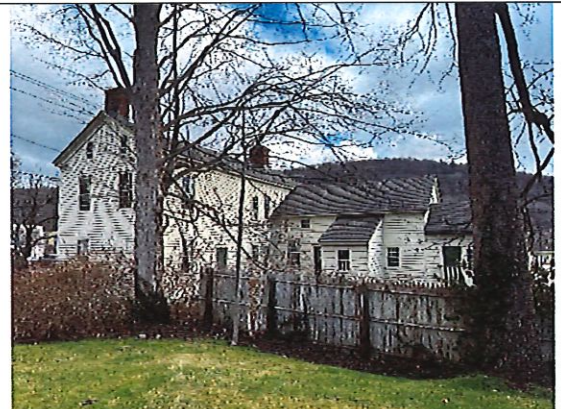
West elevation

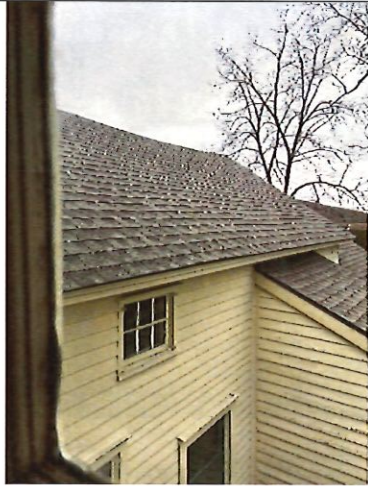
Rear facing, addition roof

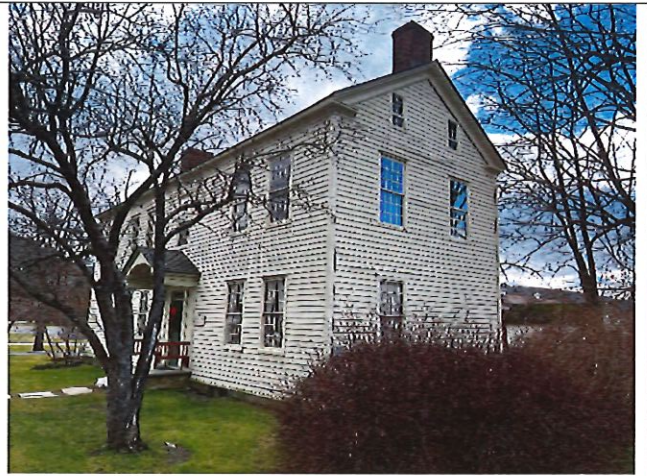
West chimney, main roof

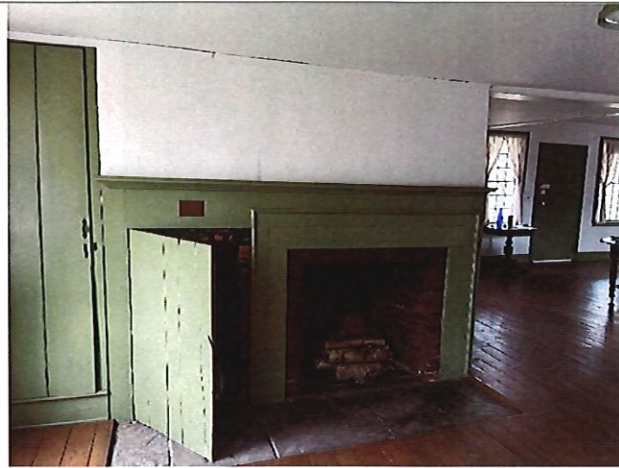
West facing room fireplace, first floor

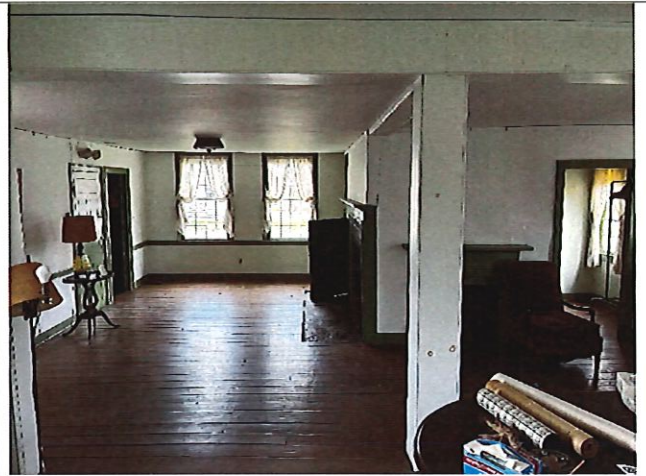
Front room, north, first floor

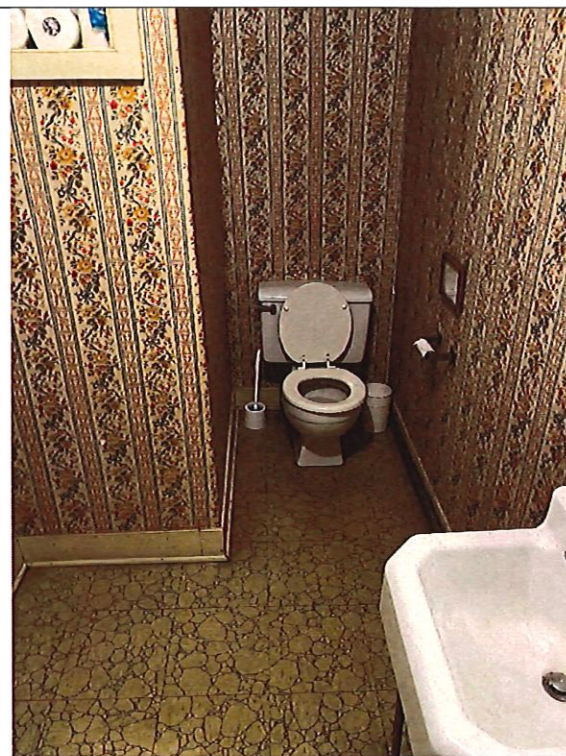
There is one toilet room on the first floor and two toilet rooms on the second floor. The fixtures and clearances do not meet ADA requirements. On the main floor space around the toilet is less than 3 feet, where 5'-0" is required. This toilet room is too small and will need to be demolished along with the adjacent coat room. Combining the floor area of these two spaces is sufficient to incorporate an ADA compliant toilet room on the main floor, consisting of new walls, fixtures, accessories, and finishes. The plumbing fixtures and piping should be gutted in their entirety. New accessible toilet rooms will be required with reuse of the building.

Toilet room, first floor

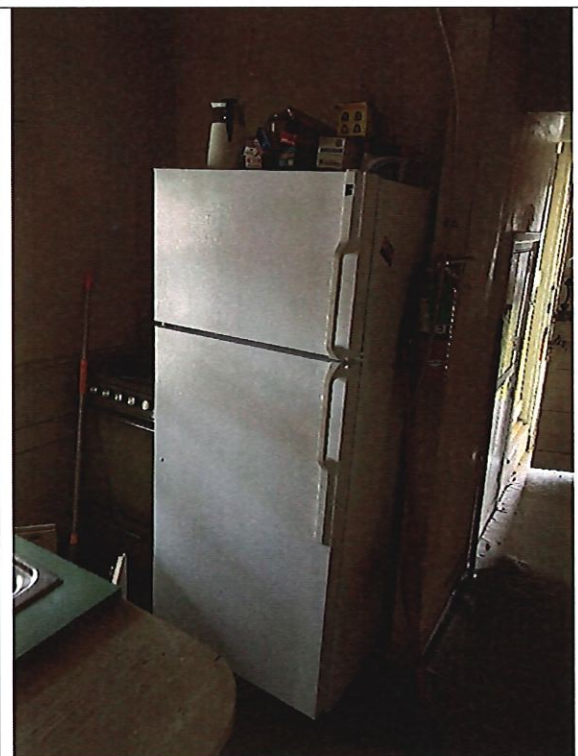
The building has remnants of a small residential kitchen in the back south addition. This kitchen on the main floor does not meet ADA requirements and should be replaced with ADA compliant countertops 34 inches from the finished floor, and a sink area with accessible clearances.

Remnants of kitchen in south addition

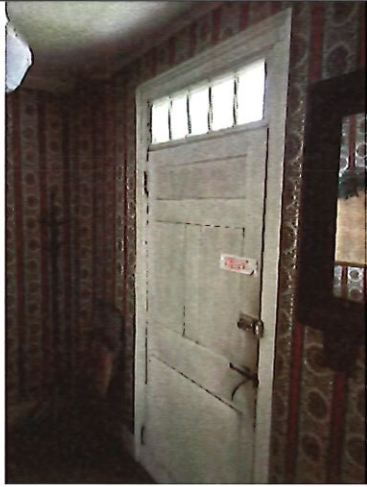
Main entrance

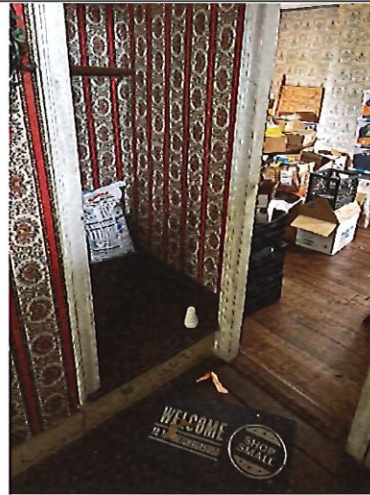
Main entry stairwell
