Swift House

March 13, 2024

HISTORIC RESOURCE NEEDS ASSESSMENT REPORT

Silver Petrucelli + Associates
3190 Whitney Avenue | Hamden CT 06518
311 State Street | New London CT 06320
203 230 9007 silverpetrucelli.com

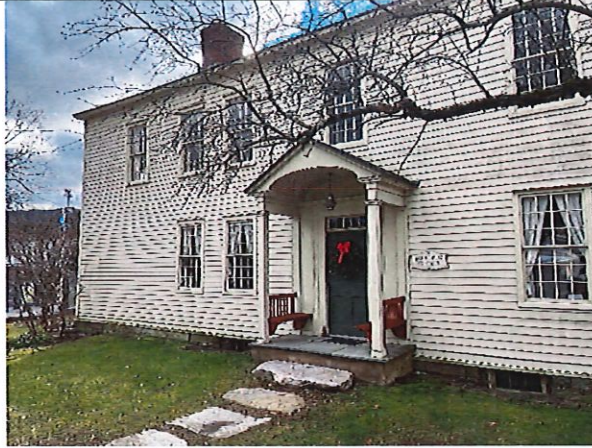
Front entrance on Maple Street

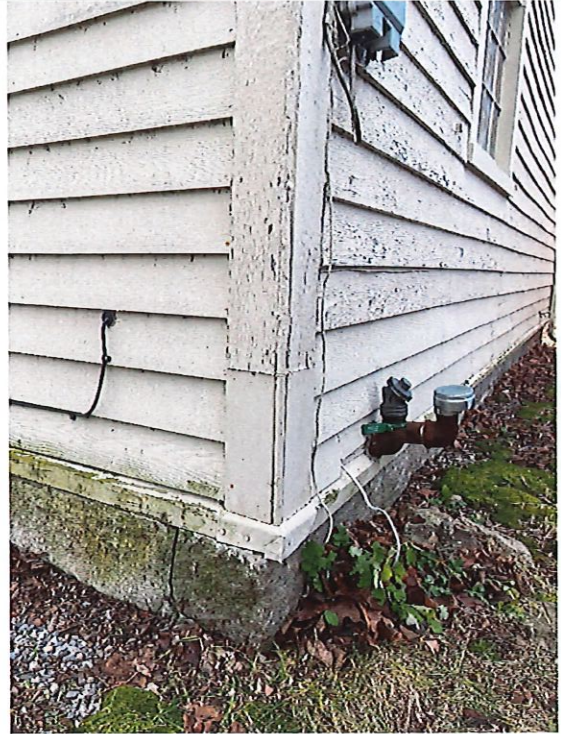
Façade damage

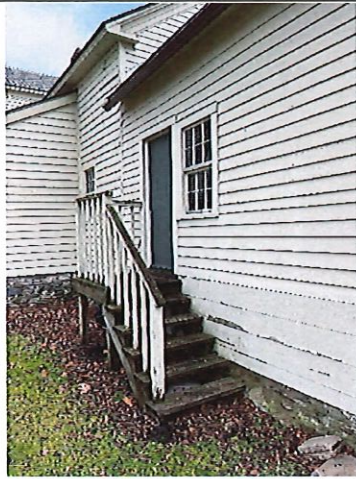
Back steps

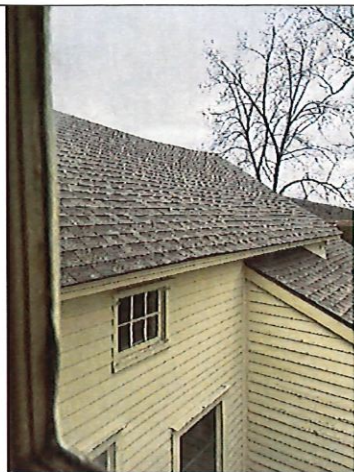
Rear facing, addition roof

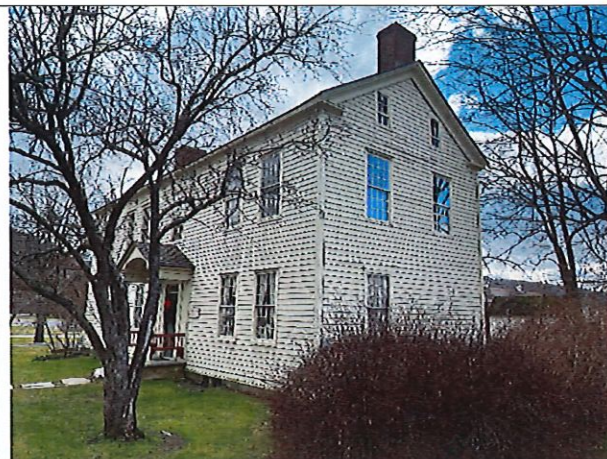
West chimney, main roof

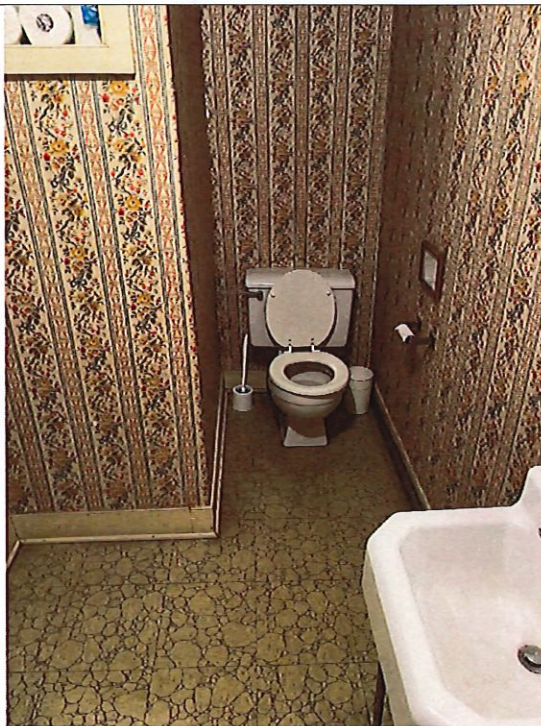
Toilet room, first floor

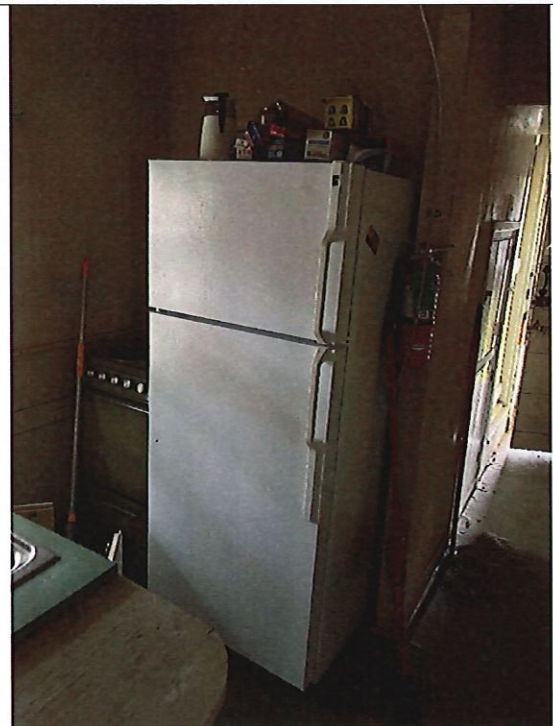
Remnants of kitchen in south addition

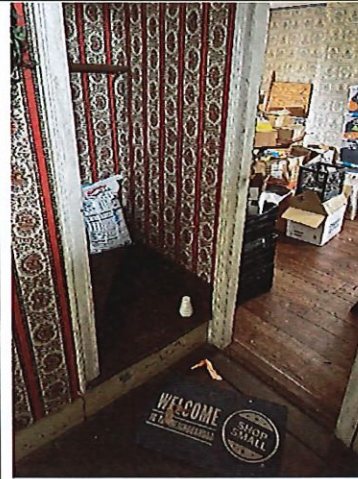
Main entry stairwell
